# RFQ Question and Answer List

| Project Name | <u>Perry Stadium Phase 1 Repairs/Upgrades</u> | Project Number | <u>BGU 156088</u> |

# BGSU Doyt Perry Stadium, Bowling Green, Ohio/// FACILITY CONDITIONS ASSESSMENT

ROSSETTI was retained to provide a Facility Conditions Assessment for Bowling Green State University, related specifically to Architectural and Structural areas. The structural review + testing requirements follows the architectural review starting on page 13.

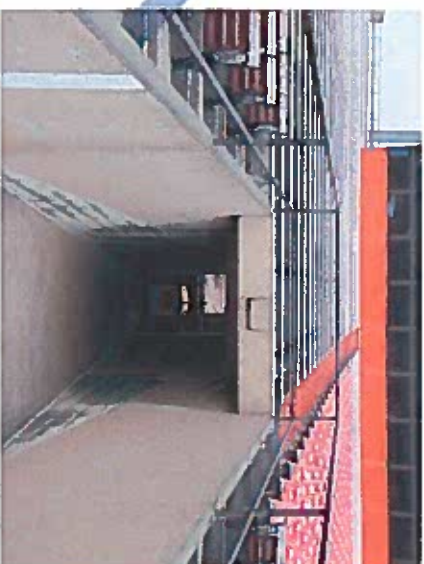
**PUBLIC RAMPED WALKWAYS:** The seating bowl is primarily accessed from (8) large ramped walkways, with a distinctive "Y" shaped entry into the seating bowl (refer to figure 3). These ramps are at a slope of 1" rise over 10" of run, as indicated on the original drawings, but they contain no landings, it is one constant slope for approx. 9 feet of vertical rise. The slope and the arrangement do not comply with current building and accessibility codes, which would require a maximum slope of 1" rise over 12" of run and a landing for every 30' of rise. In the case of this location, you would be required to provide (4) 5'-0" long level landings and revise the slope of the ramp. This would add almost 40 feet to the overall length of these ramps at each location. Handrails would also be required on each side to comply with the current building codes (refer to figure 4).

Figure 4- View of Ramped Walkway with Hand Rails

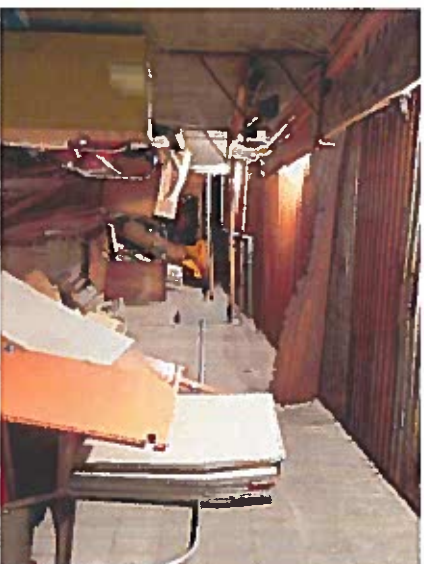
Figure 5- View of Underside of Ramped Walkway

However, the construction on the bottom side of these ramps is another issue (refer to figure 5). It was evident that the supporting metal deck has serious signs of deterioration and appears to be a safety issue for anyone accessing this space. Per the structural assessment, this is not specifically a structural concern, since this decking was used as a form for the ramp.

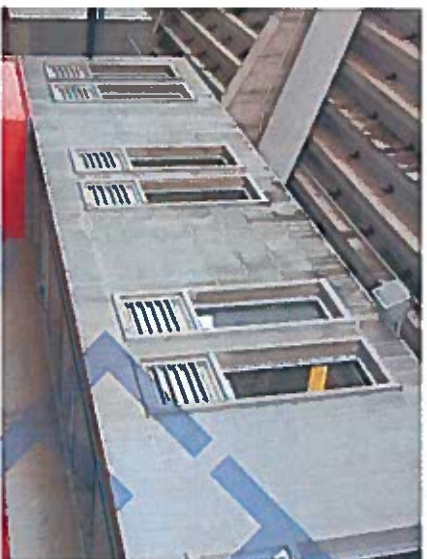
The Mezzanine Level is enclosed with CMU walls and have small windows for each office area. These offices have separate mechanical units mounted under the windows with an attached louver. Based on the existing drawings, it is not clear if any coating or sealer was installed over the exterior surface. The exterior wall is showing signs of water intrusion, noticeable from the visible staining seen on the walls (refer to figure 27). We would recommend the walls be cleaned and an appropriate sealer or coating be applied to limit water from entering the wall system. The construction of the Mezzanine also has an overhang condition that has the floor slab exposed to the exterior, we would suggest an insulated soffit be constructed to provide a more complete envelope.

Figure 27- Mezzanine Exterior Wall- Staining

The windows appear to be original to the facility and are 3/16" gray tinted single pane units per the drawings. These units should be replaced with insulated glass and associated sealant in order to extend the life of the facility. The insulation of the walls and roof should be increased as well.

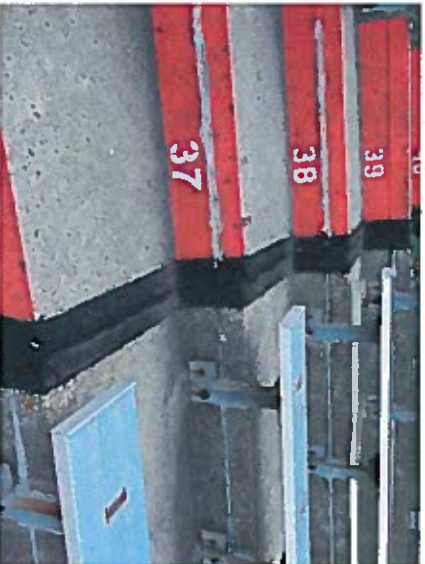
**SEATING JOINT SEALANT:** The sealant installed within the seating bowl is in various states of decline, as part of any major renovation, the sealant should be removed and replaced complete (refer to figure 38).

Figure 38- View of Seating Bowl Sealing Joint

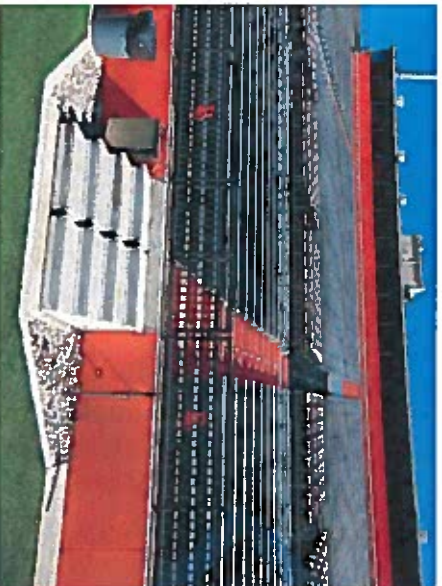
**FIELD ACCESS STAIRS/ EGRESS TO FIELD:** The sealing bowl relies on egress into the field in the event of emergency to accommodate all the spectators. These stairs (7) locations per side do not provide the required railings. These railings should be provided (refer to figure 39).

Figure 39- Field Access Stairs

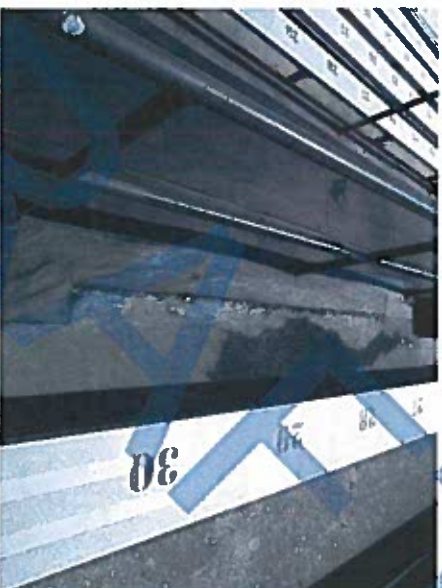
**TRAFFIC COATING/ WATERPROOFING:** Various methods of waterproofing and traffic coatings have been installed over the occupied areas. In some areas, a membrane has been installed, but it is obvious that water has gotten under the membrane and is trapped between the concrete. This membrane has now delaminated from the concrete. We would recommend that this membrane be removed and the traffic coating be reviewed at all locations (refer to figure 40).

Figure 40- View of Delaminated Membrane

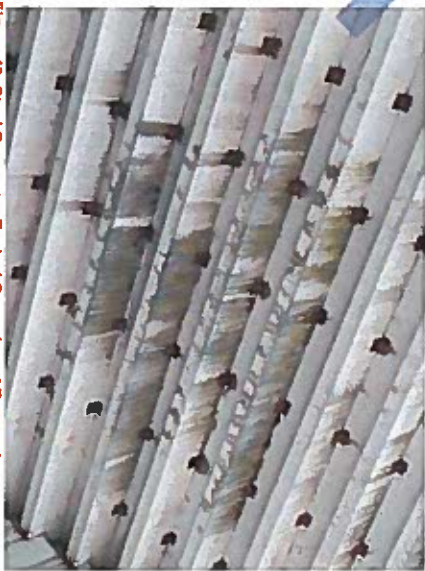
Few connectors were found to be in near to original condition (refer to figure 42). However, majority of the connectors that connect precast risers together show signs of corrosion.

Figure 43: Steel Connector Typical Corrosion of Exposed connectors

- *Testing: Desai/Nasr recommends removing two to five of these clip angles and their bolts to determine the condition of the bolts and inserts and rate of steel deterioration. Test results to be used to estimate the remaining life and what, if any, remedial measures are required to slow or stop this corrosion (short term).*

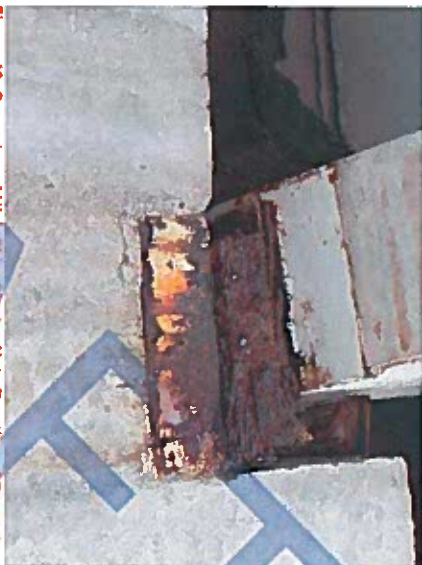
**Figure 46- Corrosion of High Shim Stack - Note Rotation of Precast Beam**

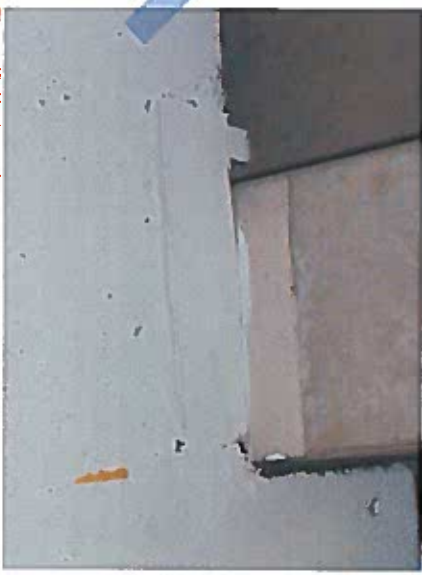
The only location where no corrosion of the embedded plates was observed was at the expansion joint where the plates were not welded together (refer to figure 47).

**Figure 47- No Corrosion at Expansion Joint - No Welds**

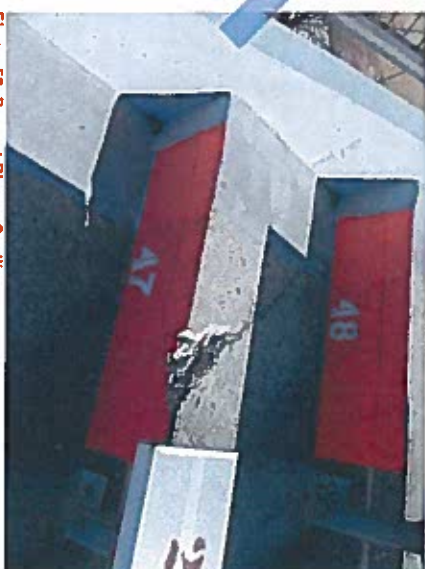
Small areas of spalled concrete were observed on the top side of the stadia. The majority of spalls were observed in the access aisles that carry most of the foot traffic (refer to figure 52).

Figure 52- Precast Riser - Spalling

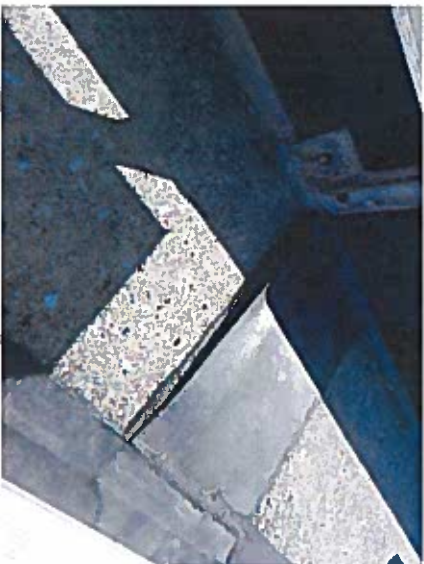
Figure 53- Waterproofing Membrane at Joint - Failure

**Comment:** To reduce the amount of water leaking through the structure into occupied spaces below and corroding the steel connections, a traffic coating is recommended to be applied to the entire top surface of the elevated precast risers and cast-in-place top slab areas. This work should only be carried out after all the other structural issues identified have been addressed (short term/future depending on severity of leaks).

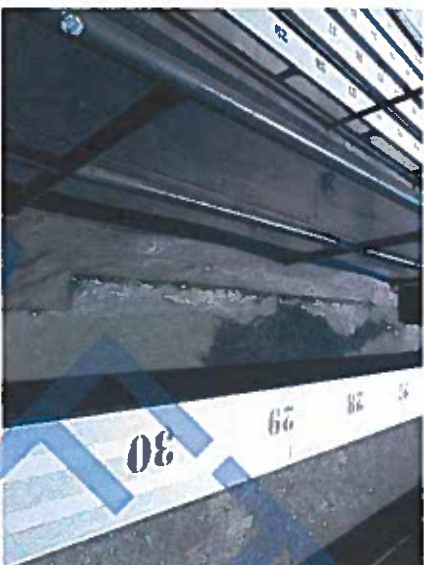
Figure 54- Waterproofing Membrane at Precast Top - Failure

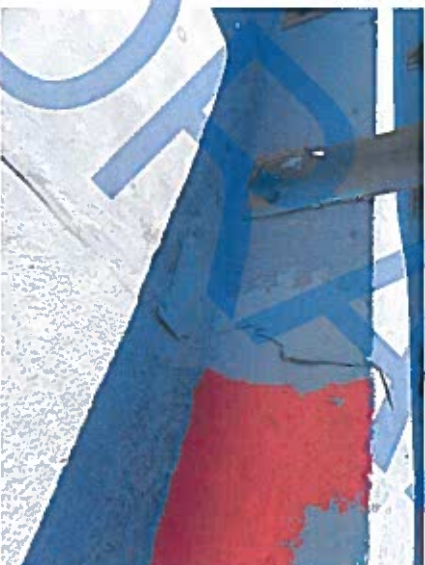
Figure 55- Applied Traffic Coating - Failure at Joint

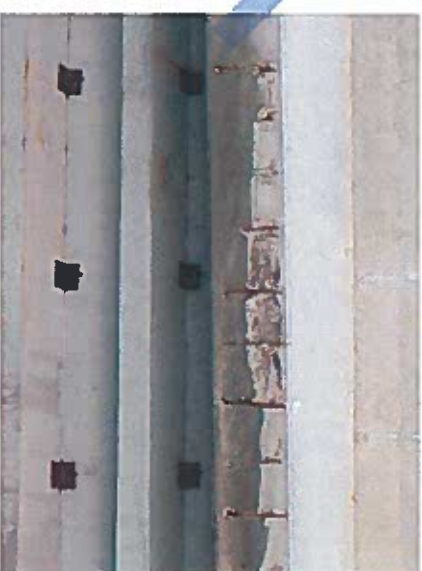
**MAIN LOAD BEARING FRAMES:** Minor spalling of concrete due to insufficient cover to shear ties was observed at two elevated beams (refer to figure 56).

Figure 56 - Concrete Spalling at Main Frame Beam

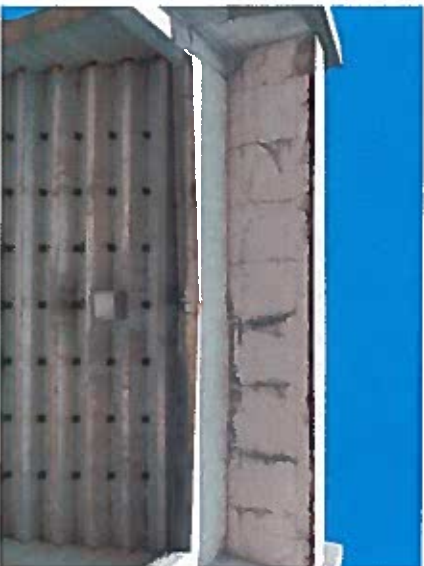
**Figure 57- Shrinkage Cracking in Concrete**

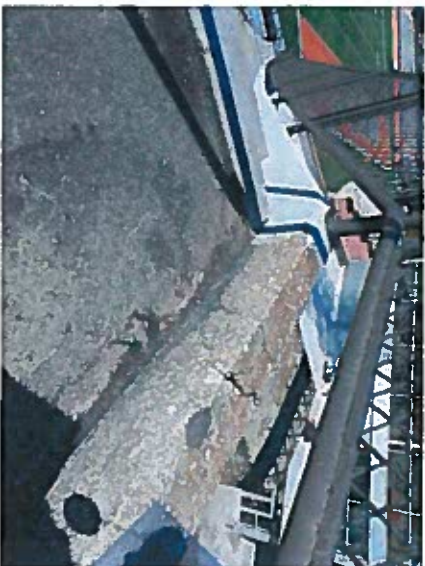
**Figure 58- Deterioration of Slab and Curb**

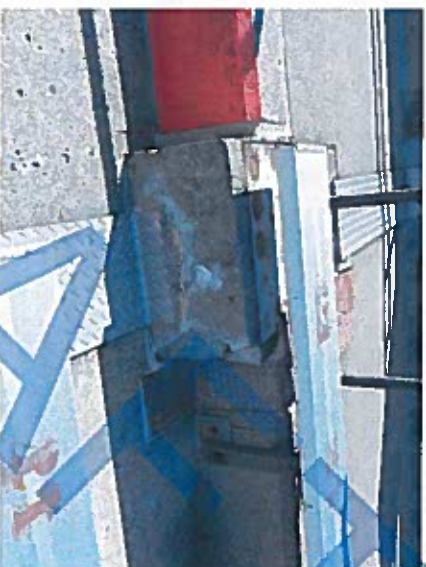
embedded steel plate (refer to figure 59). The probable cause of this concrete deterioration is freeze/thaw cycling in concrete with no entrained air.

**Figure 59- Deterioration of Exposed Concrete Column at Embed Plate**

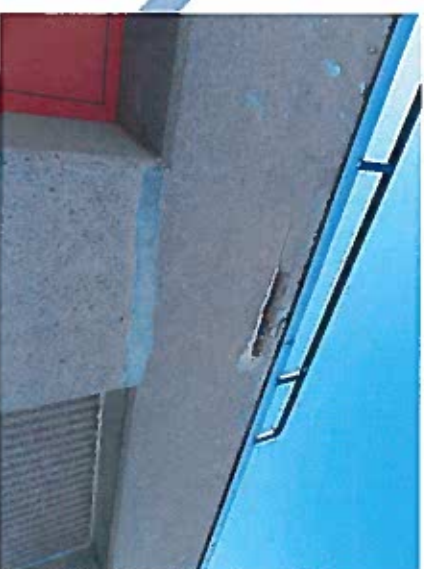
**Figure 60- Spalling of Concrete Encasement at Embedded Steel Beam**

**Comment:** The damaged concrete should be removed, the exposed steel cleaned, a corrosion inhibiting bonding agent applied and area patched with a suitable trowel applied mortar (short term).

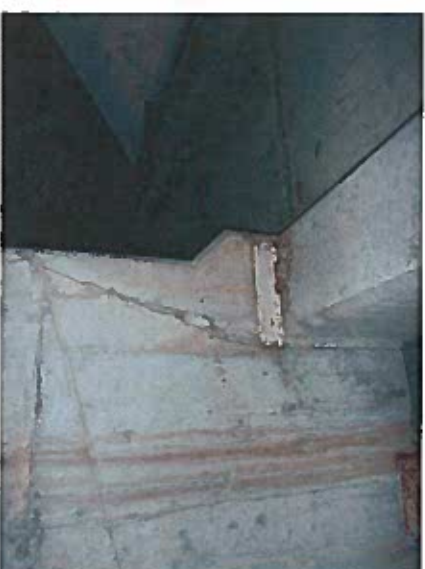
In the concessions kitchen area below the west stand a shear crack was observed in the corbel. This crack is a sign of shear failure (refer to figure 61).

**Figure 61- Cracking and Failure of Corbel**

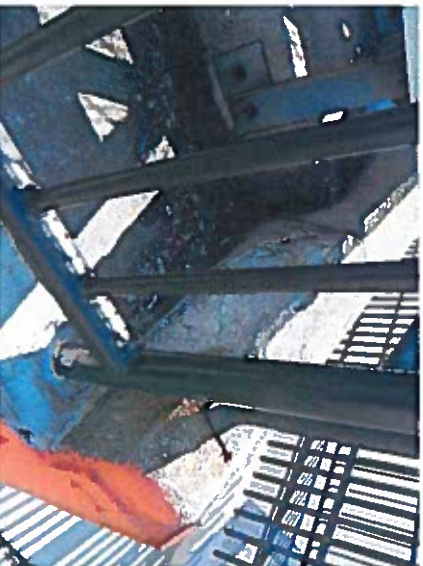
Alkali-aggregate reaction is an expansive chemical reaction between certain minerals found in course aggregate and the alkalis in Portland cement resulting in expansion, cracking and failure of the concrete matrix. Standard practice is to entrain air at a rate of approximately 6% for concrete, with ¾ inch nominal aggregate, subjected to severe exposure. Air content was measured at 2% to 3% in the damaged portion of the wall.

Figure 62- Deterioration of Concrete Retaining Wall

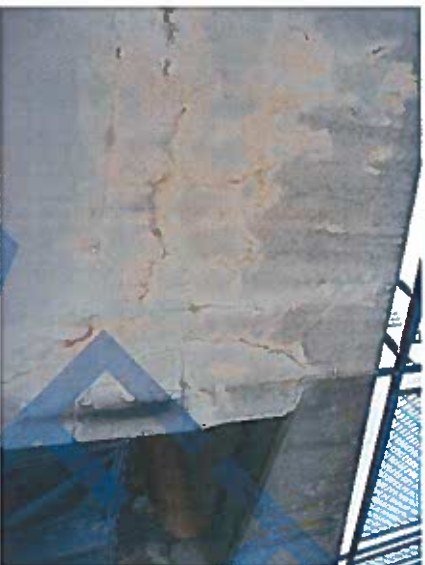
Figure 63- Deterioration of Concrete Retaining Walls

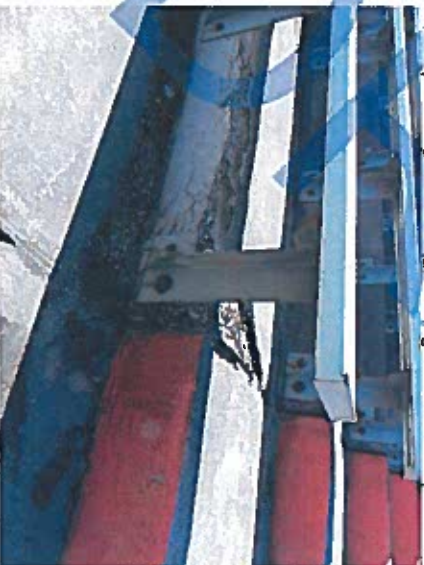
Damage and deterioration of the concrete was also observed on the second and third riser of the stadia, the side retaining walls and steps down to the field (refer to figures 64 and 65).

Figure 64- Deterioration of Cast-in-Place Concrete Risers

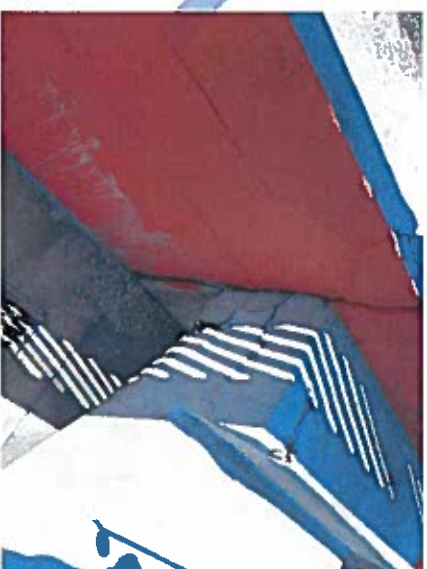
Figure 65- Deterioration of Concrete Stair and Wall

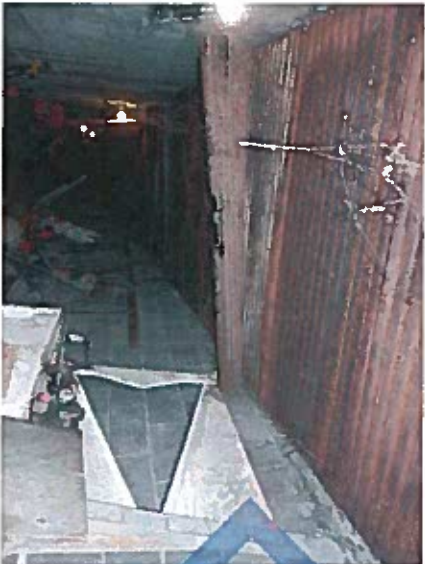
The sloping cast-in-place concrete access ramps are supported by CMU side walls. To form the slabs during construction light steel corrugated form deck was used (refer to figure 67). Over-time, this form deck has severely corroded and is peeling away from the concrete.

Figure 67- Delaminating steel Form Deck

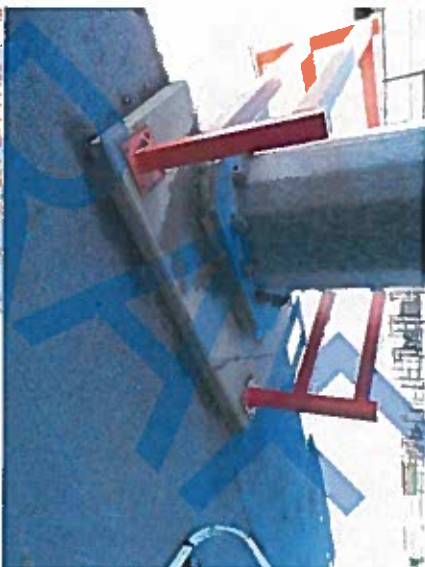
Minor deterioration of the grout bed below the light pole base plates was observed. Cracking of the concrete base slab has occurred at one location (refer to figure 68).

Figure 68- Light Pole Support Base Cracking and Grout Deterioration

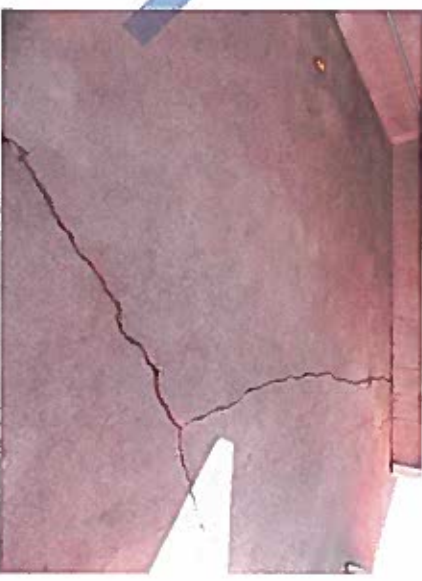
Figure 69- Frost Heave at Slab on Grade in Concessions

*Comment: Heaving concrete should be removed, fill below the slab should be replaced with frost resistant material before a new slab is cast (short term).*

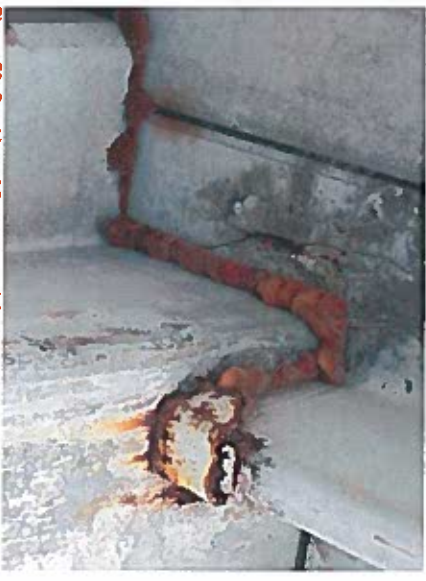
Figure 70- Cracking of Concrete and Corrosion of Steel Embeds

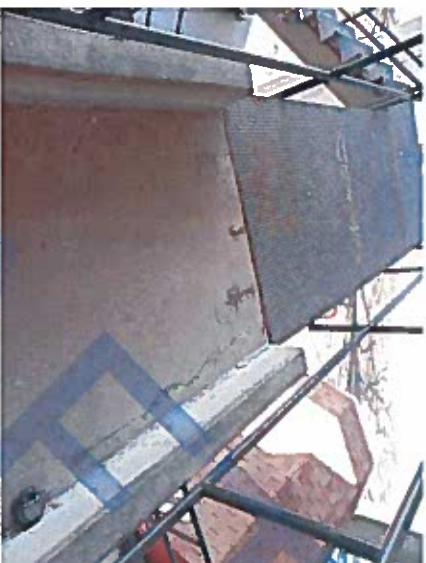
Figure 72 - Minor Corrosion of Checkered Plate Stair

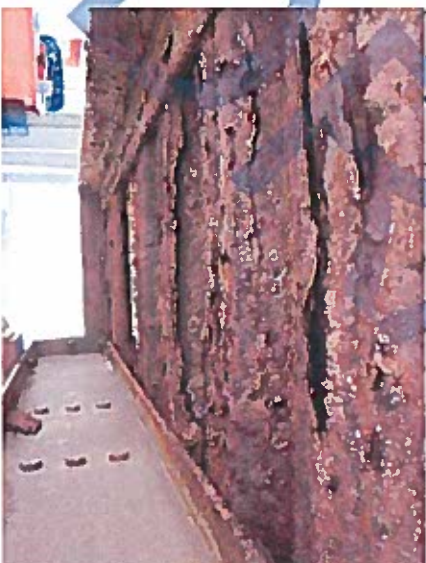
Figure 73 - Severe Corrosion of Steel and Deck at Bridge Stair

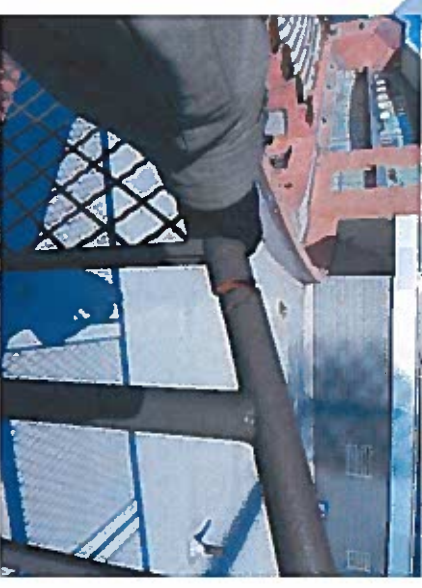
Figure 74 - Split in Guardrail Top Rail

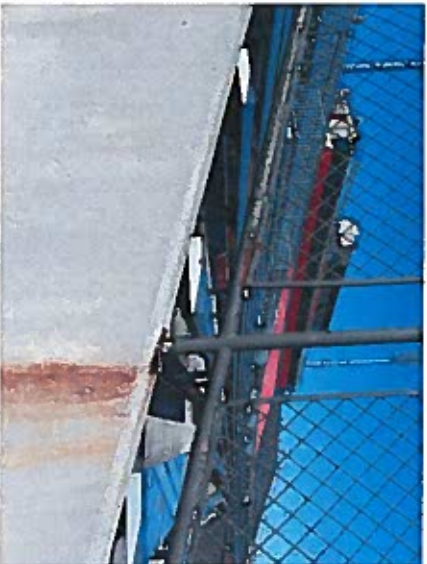
**Figure 75- Corrosion of Embed Plates and Steel Mesh Framing**

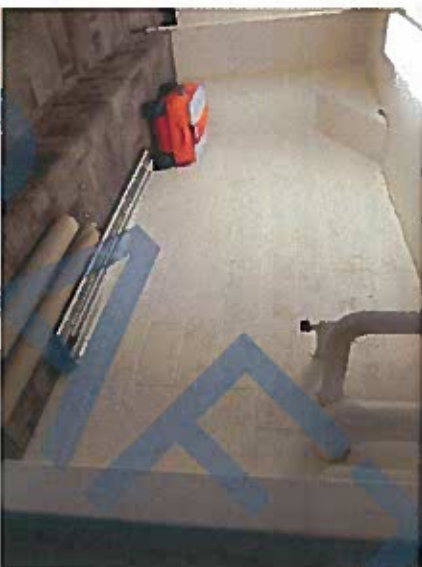
**Figure 77: Moisture Penetrating into CMU Wall From Above**

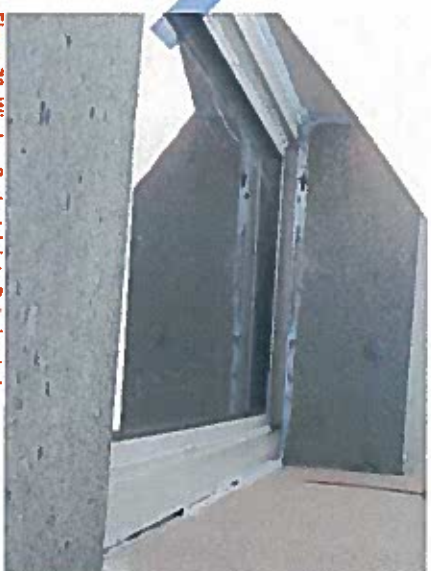
**Figure 78- Window Sealant Joint - Deteriorated**

**Comment:** Wall window sealant should be removed and replaced with a suitable flexible sealant (future).

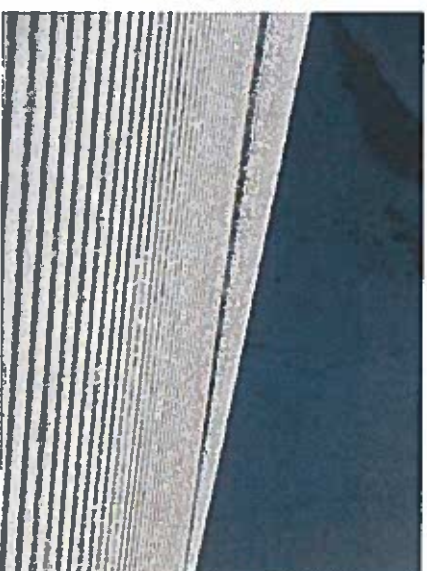
**Figure 79 - Bulge in Precast Panel**

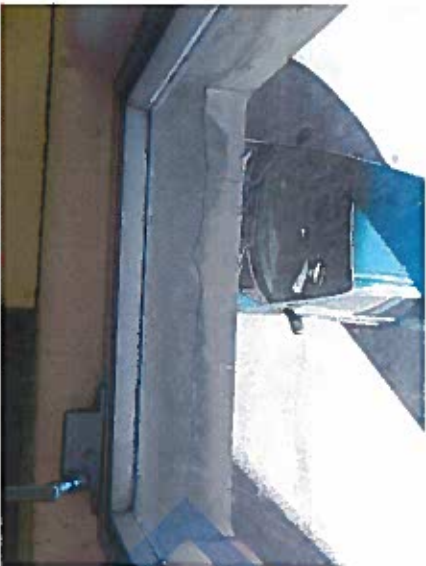
Figure 80- Crack in Precast Window Surround

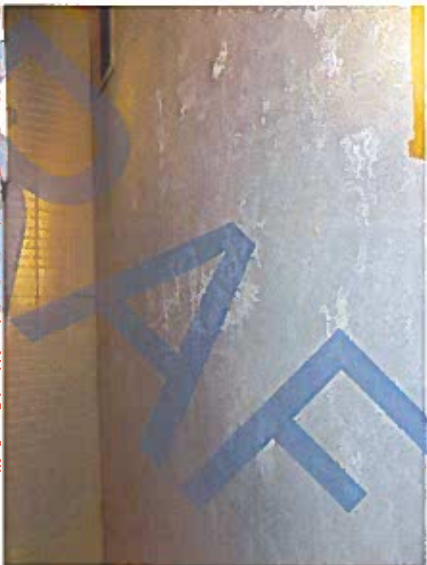
Figure 81- Humidity Corroding Under side of Hard Pan Ceiling

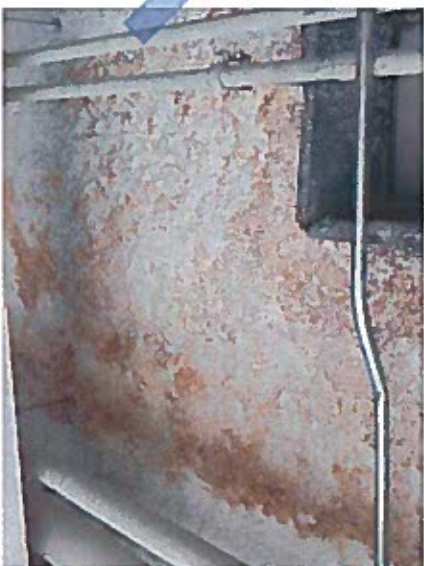
Figure 82 - Mold/Discoloration of Spray on Insulation

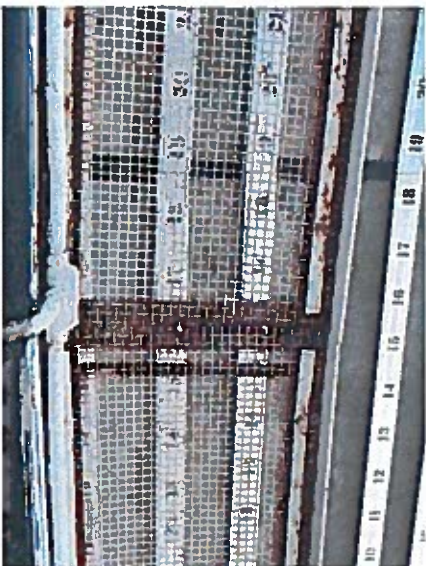
Figure 83- Corrosion of Steel Mesh Sunscreen
