# RFQ Question and Answer List

| Project Name | <u>Perry Stadium Phase 1 Repairs/Upgrades</u> | Project Number | <u>BGU 156088</u> |

# BGSU Doyt Perry Stadium, Bowling Green, Ohio/// FACILITY CONDITIONS ASSESSMENT

ROSSETTI was retained to provide a Facility Conditions Assessment for Bowling Green State University, related specifically to Architectural and Structural areas. The structural review + testing requirements follows the architectural review starting on page 13.

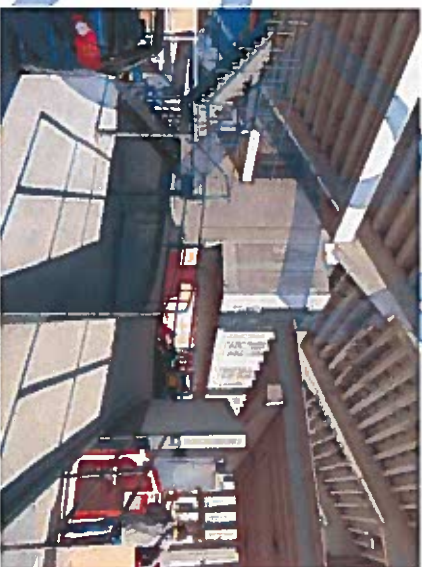
Figure 3- View of Ramped Walkway to Seating Bowl

**PUBLIC RAMPED WALKWAYS:** The seating bowl is primarily accessed from (8) large ramped walkways, with a distinctive "Y" shaped entry into the seating bowl (refer to figure 3). These ramps are at a slope of 1" rise over 10" of run, as indicated on the original drawings, but they contain no landings, it is one constant slope for approx. 9 feet of vertical rise. The slope and the arrangement do not comply with current building and accessibility codes, which would require a maximum slope of 1" rise over 12" of run and a landing for every 30' of rise. In the case of this location, you would be required to provide (4) 5'-0" long level landings and revise the slope of the ramp. This would add almost 40 feet to the overall length of these ramps at each location. Handrails would also be required on each side to comply with the current building codes (refer to figure 4).

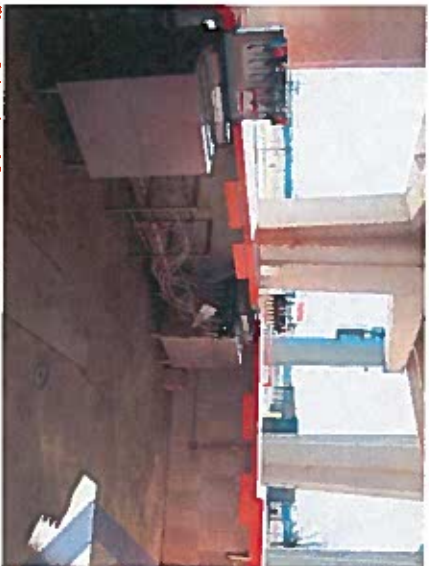
Figure 6- Interior of Concession Stand

**CONCESSION STANDS:** The existing facility contains (8) freestanding concession stands with canopies located at the base of the ramped walkways (refer to figures 6 and 7). It is unclear how many point of sales (POS) machines are setup for each location, but 2-4 POS per stand seems reasonable. This would mean a total amount of 32 POS, which equates to approx. 1 POS for every 718 spectators. This is a very high ratio for a current college facility. We would recommend that the ratio should be closer to 1:200, which would mean a total amount of 115 POS, or an increase of around 83 POS. The public counter height is 3'-6" and would need to have a lowered portion at 3'-0" max. to comply with the current accessibility codes.

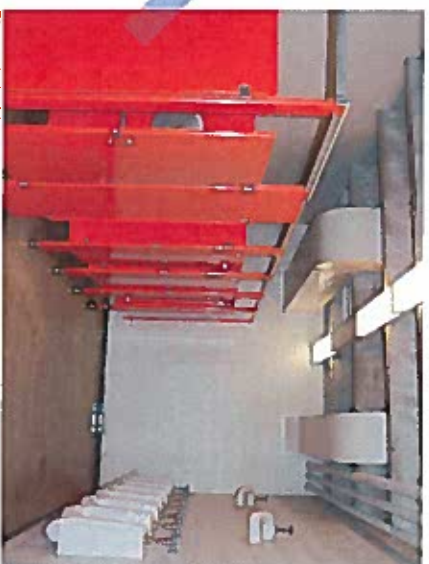
Figure 8- Public Toilets- Toilets + Urinals

**PUBLIC TOILETS:** The existing facility contains a total of (4) Men's and (4) Women's Toilet Rooms. Generally these spaces were in good condition. The painted, floor mounted toilet partitions were in good condition and the ones tested appeared stable and structurally sound. A few locations showed signs of attempts to provide wheelchair accessible stalls, although it was observed that these did not appear to fully comply. These rooms also lacked the required ambulatory stalls and many of the toilet access/entry were mounted higher than allowed (refer to figures 8 and 9). The rooms themselves had more than adequate turning clearances, however the existing entry and exit doorways do not. The quantity of existing toilets is well below the current code requirements and would need to be resolved in any future renovation.

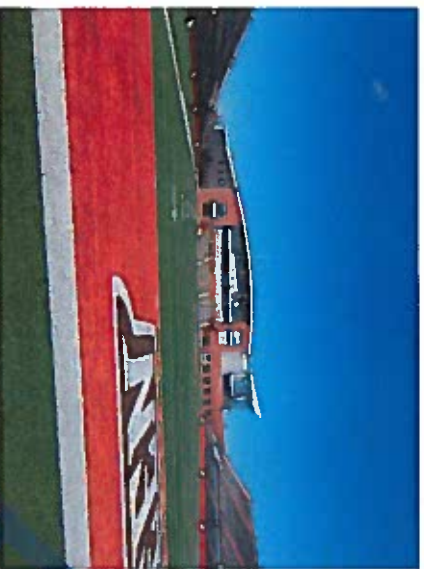
Figure 10- South End Zone looking North across Field Turf field

**FIELD TURF:** The traditional grass field was replaced with Field Turf in 2007. The condition of the Field Turf appears to be in good condition. There were no visible defects or issues with the turf (refer to figure 10).

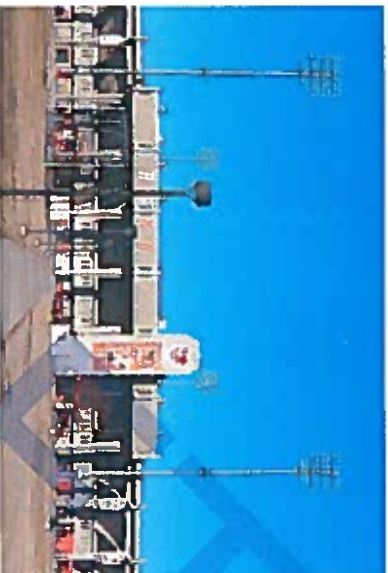
Figure 11- View of Field Lighting, 4 poles

**FIELD LIGHTING:** The field lighting is provided from (4) Musco lightpoles. The site visit was conducted during a non-event time and as such we were not able to determine if the field lighting was adequate or not. Based on observations of the lighting quantity and locations, we have no reason to believe there are problems with field lighting (refer to figure 11).

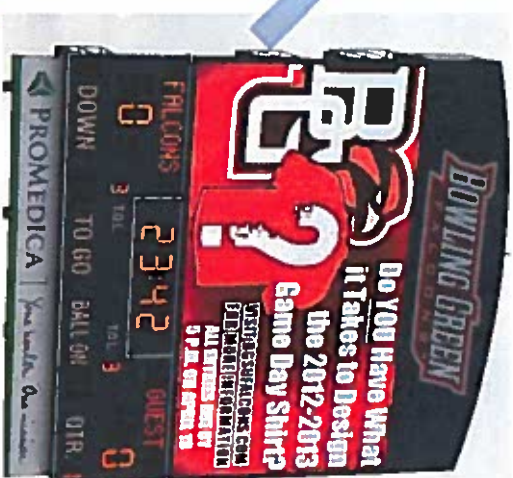
Figure 12- BGSU Video Scoreboard

**SCOREBOARD:** Located at the South end of the field is the main video scoreboard for the facility. The scoreboard was built by Daktronics, originally installed in 2004, was upgraded for the 2012 season has a 15 mm pixel pitch-spacing, and approx. 19' x 35' dimensions. The size of this board is on the smaller size for NCAA Division I football (refer to figure 12).

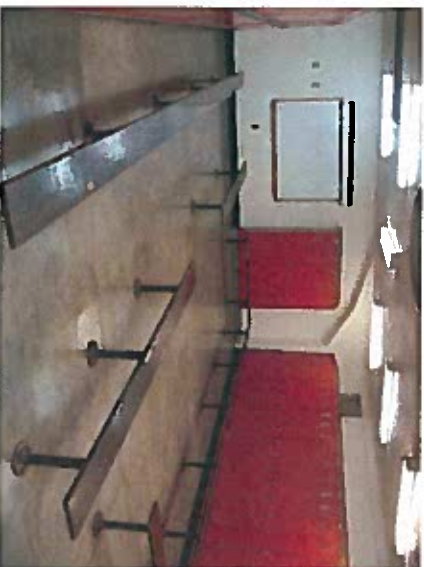
Figure 13- View of Visiting Team Lockers

**VISITING TEAM LOCKER ROOM:** The Visiting Team locker room is located in the SE corner of the facility. The room is very dated and simple, but it does appear to have enough space for the intended use. We assume this room is used for all visiting teams (Football, Track, Soccer, etc...). We did not observe separate training facilities for the Visiting Teams, and all areas including the toilet and shower areas appear to be non-compliant with accessibility guidelines (refer to figure 13).

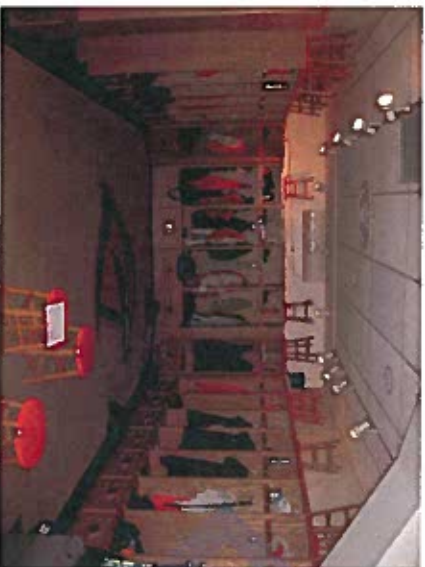
Figure 14- View of BGSU Men's Soccer Lockers

**FALCON'S TEAM LOCKER ROOMS (Track/Cross Country, and Men's Soccer):** The various BGSU teams noted above located within the facility are generally dated and in need of revisions (refer to figures 14 and 15).

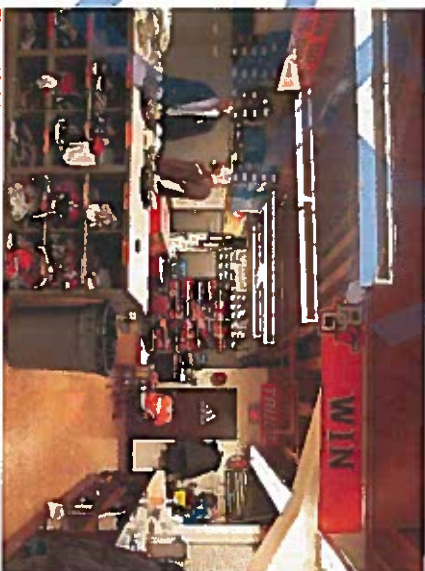
Figure 16- View of Athletic Equipment Storage Room

**FALCON ATHLETIC EQUIPMENT ROOM:** The Athletic Equipment Storage room appears to be well organized and able to support the intended uses. The addition of more space would allow for a higher capacity storage system (refer to figure 16).

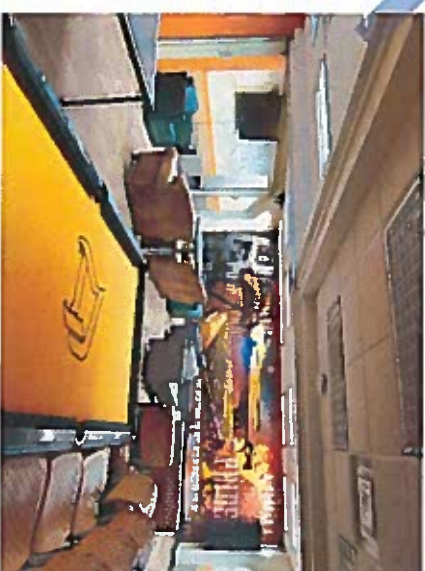
Figure 17- View of Player's Lounge

**PLAYER'S LOUNGE:** The Player's Lounge appears to be very small in size for the number of athletes it should serve. The current layout appears to have four activities, but it would be difficult to accommodate the number of people needed. The room is also dividable into three smaller spaces for multiple meetings. We would recommend that this room be increased in size to allow for more comfort and relaxation for the athletes (refer to figure 17).

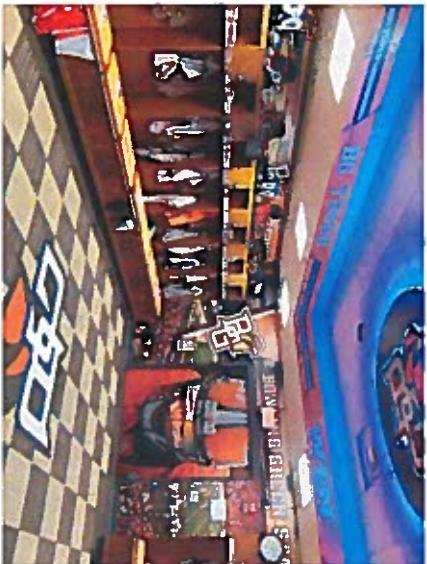
Figure 18- View of Football Locker Room

**FALCON FOOTBALL TEAM LOCKER ROOM:** The Falcons Football Locker Room was recently renovated in 2007 as part of the Sebo Center project. The room appears larger and more spacious than the other locker rooms, with detailed wood lockers. The space appears very modern and comparable to other current major NCAA locker rooms with nicely done signage and graphics (refer to figures 18 and 19).

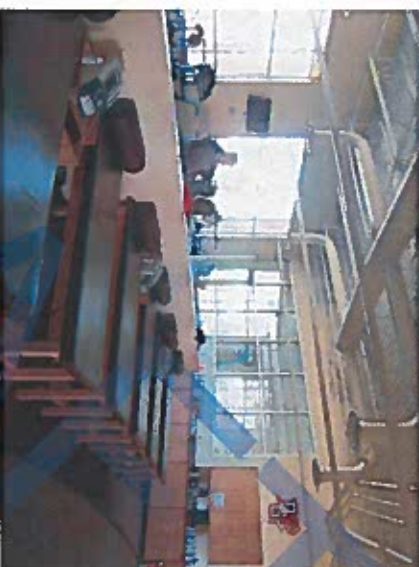
Figure 20- View of Sebo Training Room

**FALCONS TRAINING ROOM** (located in the Sebo Center): The Training Room for the Falcon's is part of the Sebo Center and was constructed in 2007. This room is for all of the various sports located in the facility. The room generally appears

a adequate for the intended use including treatment and taping tables, and multiple hydro tubs for therapy (refer to figure 20).

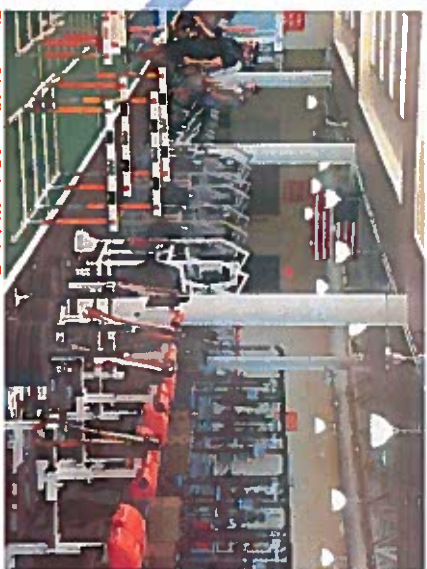
Figure 21- View of Sebo Weight Room

**WEIGHT ROOM** (located in the Sebo Center): The Weight Room for all associated BGSU sports is located in the Sebo Center and was also constructed in 2007. The room seems well equipped and in good condition. The issue is that the room is primarily used by the football team and the other sports have limited access for using this space. It would be recommended to either increase the size of the room or to provide a separate room for the other sports to utilize (refer to figure 21).

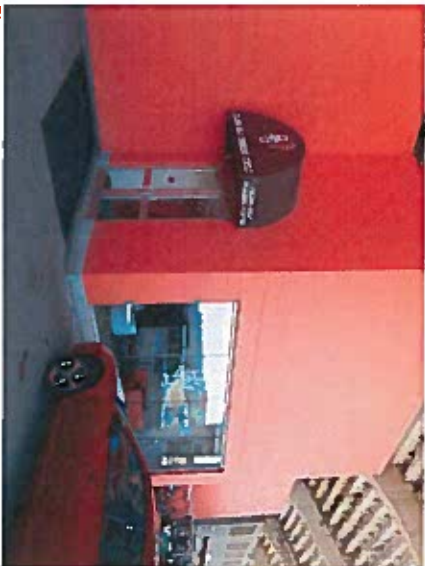
Figure 22- View of Falcon Golf Training Center

**FALCON GOLF TRAINING CENTER:** The west side of the facility is dominated by the home of the BGSU Golf Training Center, filled with a 1,200 square foot putting green, locker rooms and hitting bays. The complex was created within the (4) original handball courts. This complex appears to be a very unique feature that is available to the BGSU golf teams (refer to figure 22 thru 24). The associated locker rooms however, are very small and dated and could have some renovations to improve them but the golf training complex appears in good condition. Within the center, the Men's Cross Country team also appears to have their lockers located, we would recommend in a renovation, that these lockers be relocated.

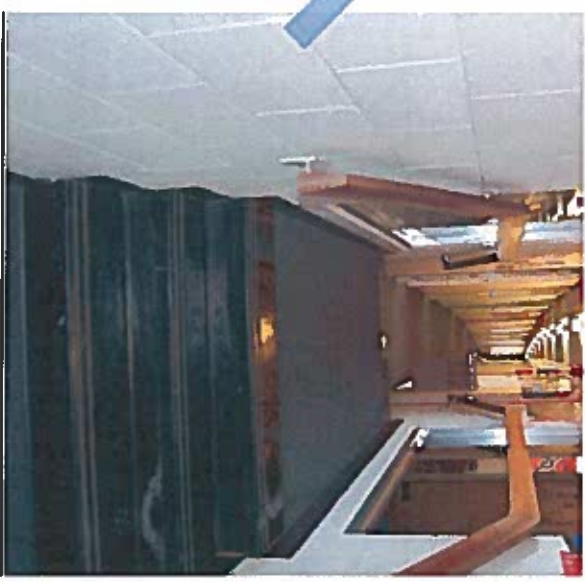
Figure 25- View of East Corridor Stairs

**OFFICE CORRIDOR:** The East side Mezzanine Level runs under the full length of the seating. It contains various athletic and coaches offices and some associated conference, storage and related mechanical rooms. The enclosed portions like toilets and conference rooms on the North side have been constructed with a sub-roof system under the precast stadia. Many of these areas show signs of previous water damage over the years. The East office hallway is clean and well lit. Besides the water intrusion issue, the major item of note was the non-accessible hallway with the stairs located at each of the ramped walkways (2 locations within corridor). Actually, although a few offices on this level actually comply with the ADA due to the addition of the elevator in 1995, none of the toilet rooms do. This area would need to be resolved in any proposed renovation (refer to figure 25).

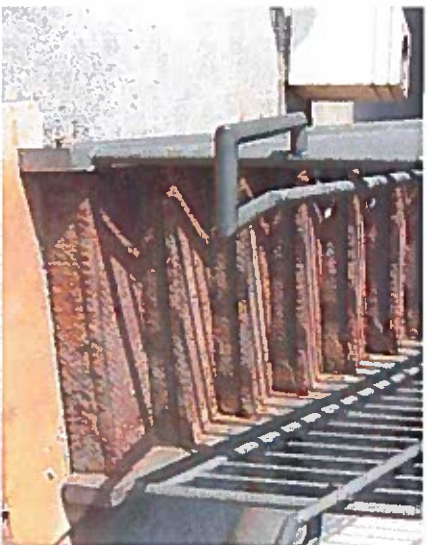
Figure 26- East Side Elevator Bridge Exit Stair- Corroded Steel

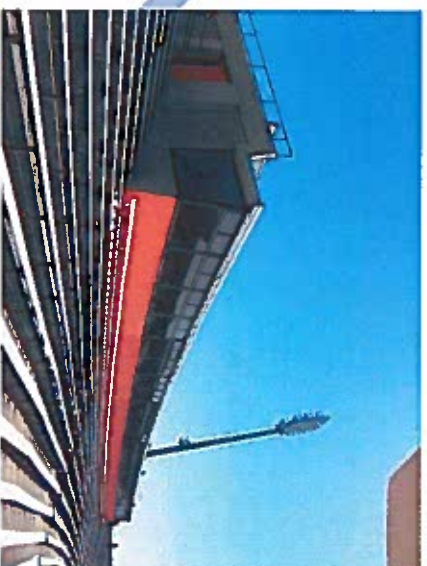
**SELECT SEATS/SUITES (EAST SIDE):** Along the East Side of the grandstands, there are (8) Suites and (1) President's Suite contained in a single story structure. It is accessed from the elevator and thru the seating bowl (refer to figure 28). The Suites contain two rows of seating with sloped glass toward the field. The sizes of the suites are very small in comparison to other football facilities. They are dated and lack space to provide much beyond the seats viewing the event. We would recommend a Suite Renovation to start within the next 3-5 years that would create a fresh new look for the Suites and associated spaces. The glass facing the field contains large vertical mullions that block some of the view (refer to figures 29 and 30). The President's Suite, with the associated lounge area behind, seems appropriate for its use.

Figure 28- View of East Side Select Seats/ Suites

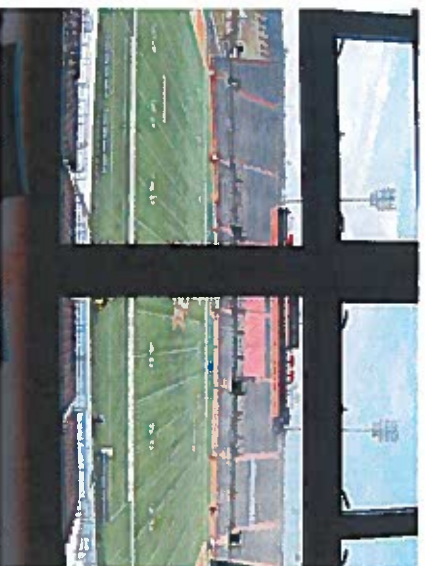
Figure 29- View from the President's Suite @ 50 Yard Line

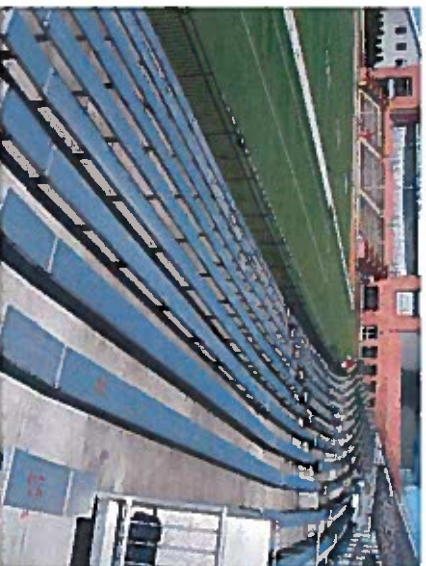
tight by stadium standards today (refer to figure 34).

Figure 34- View of General Admission Bench Seating

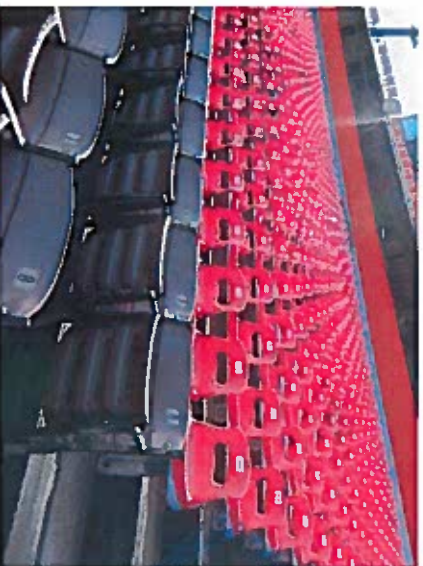
**CHAIR BOX SEATING:** Along both sides of the grandstands there are sections containing (6) rows of chairback "Box" seating. Also, the West side grandstand, within the middle seating sections there are also individual seat modules mounted to the existing aluminum benches (refer to figure 35).

Figure 35- View of Box Seats

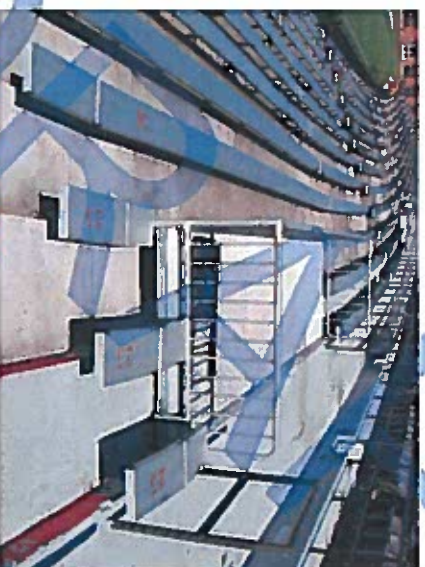
**ACCESSIBLE SEATING PLATFORMS:** In recent years accessible seating platforms have been installed over three existing rows (refer to figure 36). This occurs within the stadium at (4) locations on each side. These platforms appear to provide capacity for roughly 4 wheelchair and 4 companion seats. This would mean the facility has roughly 32 wheelchair and 32 companion total locations. This is less than what is required in the 2010 ADA Guidelines. Per these guidelines, 126 wheelchair and 126 companion seating is required. Also when the elevators were added to the facility, vertical dispersion should likely have been provided as well, this would allow for seating locations at the top of the bowl as well on both sides.

Figure 36- View of Accessible Seating Platform

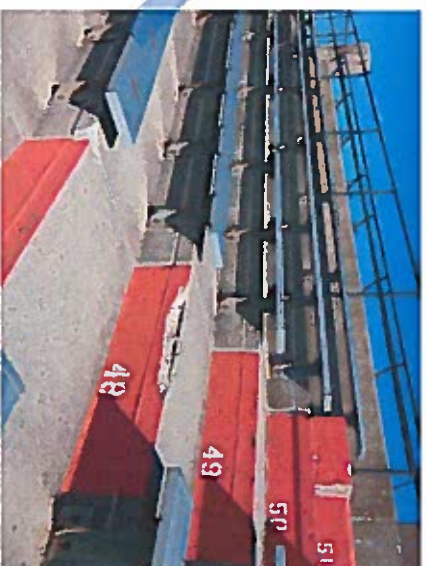
**STADIA:** The precast stadia appears to have no coating over most of the seating bowl. There are a number of locations that have a traffic coating applied over occupied areas. This coating appears to have been repaired multiple times over the years, as the water damage underneath is visible. We would recommend a heavy duty coating be applied over all surfaces to help protect the concrete. There are areas of the precast that have been damaged by water penetration and require repair (refer to figure 37). The seating bowl does not have a center aisle railing which has improved safety results and is required by the Building Code. We would recommend adding this missing aisle railing to improve usability to an aging population.

Figure 37- View of Stepped Aisle

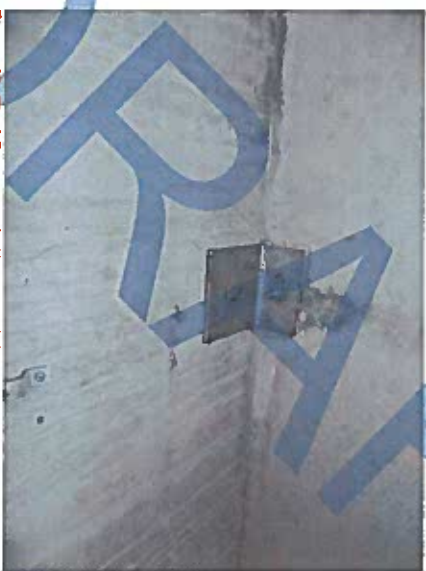
Few connectors were found to be in near to original condition (refer to figure 42). However, majority of the connectors that connect precast risers together show signs of corrosion.

Figure 42: Steel Connector in Near to Original Condition

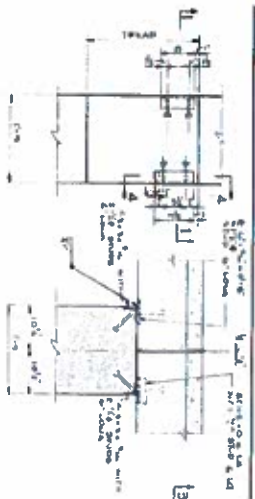
Steel plates and angle embeds in the ends of the precast risers and concrete frame transfer load from the precast riser to the concrete frame. These plates and angles are welded together to transfer lateral loads between members. The details are clearly illustrated on Osborn-Papesh drawings sheet S-3 (refer to figure 44).

**Figure 44- Precast Riser to Cast in Place Frame Typical Connection**

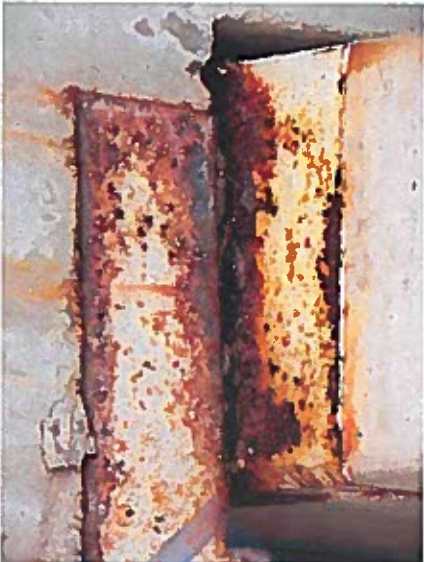
During construction, steel shim stacks were used to level the precast risers and make up construction tolerances. These shim packs vary greatly in number and thickness of plates used. In an attempt to comply with the original details, the shim packs were welded together and to the embedded steel inserts. This steel assembly was observed to be moderately to severely corroded. The most severe corrosion was observed where the shim packs are high and/or where the shim plates were thin (refer to figure 45).

**Figure 45- Corrosion at Thin Shim Plate - Welded completed Deteriorated**

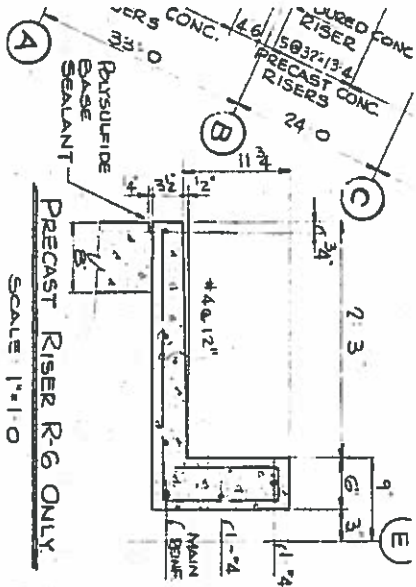
The horizontal and vertical joints between the precast risers are filled with polysulfide base hard sealant, according to the original drawings (refer to figures 48 and 49). The sealant observed in these joints appears to be mainly the original sealant, other than locations where various repairs and patches have been applied below layers of waterproofing and traffic coating.

Figure 48- Precast Riser Joint Sealant Details - Horizontal Joint

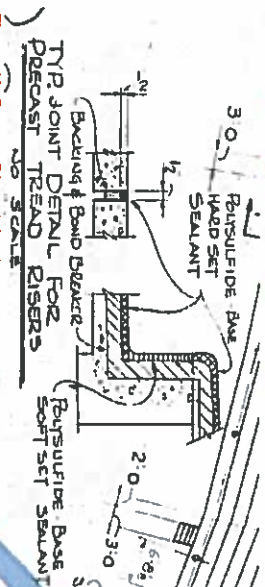
Figure 49- Precast Riser Joint Sealant Details - Vertical Joint

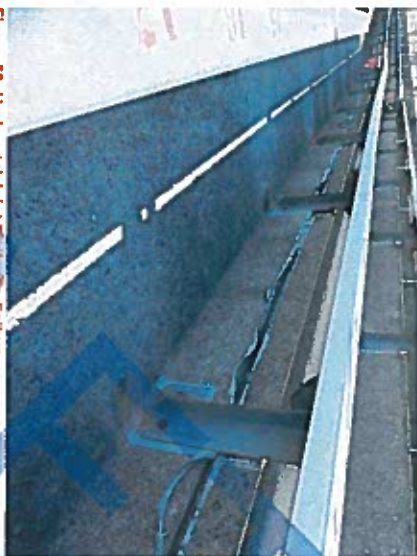
This hard compound can resist limited movement due to expansion and contraction of the structure. The joint, especially the vertical has been damaged by the amount of movement observed due to jacking of the shim stacks allowing water to leak through the joint accelerating the corrosion of the steel embeds and shim stacks below (refer to figures 50 and 51). The joint sealant is beyond its serviceable life and should be removed. There is over 35,000 lf of joint sealant.

Figure 50- Horizontal Joint Sealant Failure

**Comment:** Joint sealant should be removed and replaced with a durable compound that can expand and contract as required. Replacing the joint sealant should only occur after the corrosion of the steel embeds and shim stacks has been addressed (future).

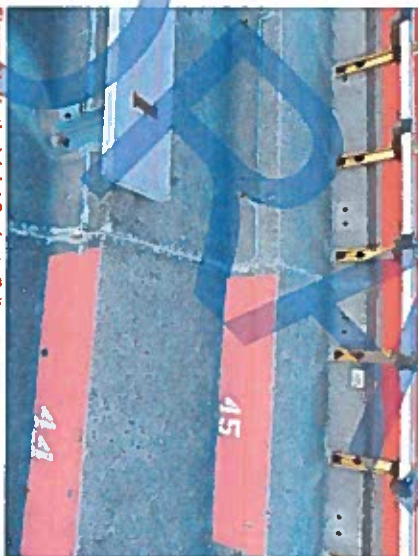
Figure 51- Vertical Joint Sealant - Failure

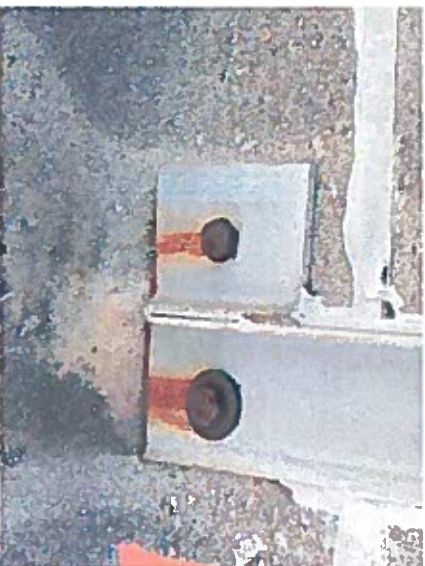
The design drawing shows steel inserts cast into the precast risers for attaching the vertical seat supports. Although the bolts used are not galvanized they appear to be in acceptable condition considering their age (refer to figure 71). Replacing seats may require a custom connection to take advantage of the existing embeds or the use of expansion or adhesive anchors.

Figure 71 - Typical Seat to Precast Connection

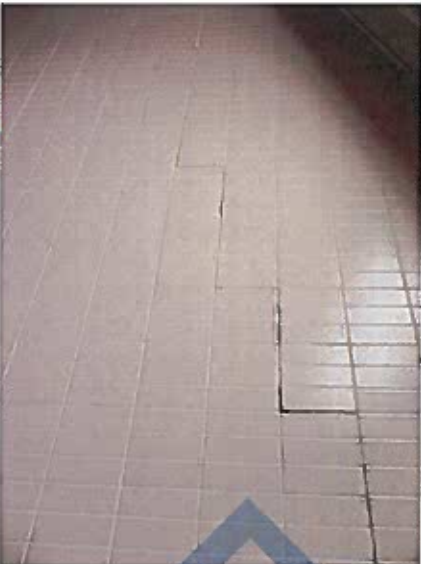
Stepped cracking in two CMU bathroom divider walls were observed (refer to figure 76). The cracking appears to be caused by excessive deflection of the supporting structural members.

**Figure 76- Stepped Crack in CMU Wall**

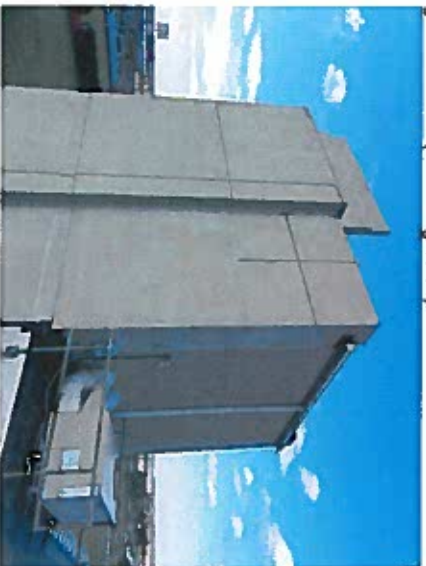
The precast panels surrounding the elevator towers appear in good condition (refer to figure 84).

Figure 84- Elevator Tower

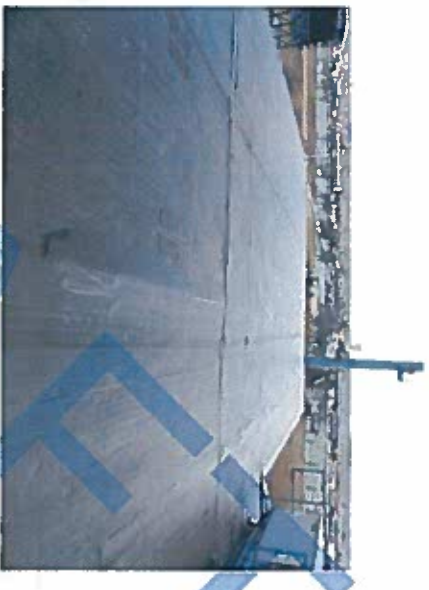
The high roofs above the boxes areas appear to be sound with no signs of cracking, delamination or hardening. There are areas underfoot that appeared soft and/or bulging (refer to figure 85).

*Comment:* Soft spots in the roofing along with signs of leaking due to discolouration of spray-on material indicate the need for further investigation (future).

Figure 85- High Roof Membrane

*Testing:* The membrane roofing should be inspected by a qualified roofing specialist to determine the need for repairs and remaining serviceable life (short term).
